**Flood Control Project Maintenance  
Levee Inspections**

## Maintenance Issue Types Only, Levee Inspection Report By Mile - Spring 2016

### Reclamation District No. 0554 Walnut Grove

Waterway	Bank	Unit Miles	Inspection Start/End	Inspector
Unit No. 01 Sacramento River	Left	1.13	03/16/2016 03/16/2016	Herman Phillips

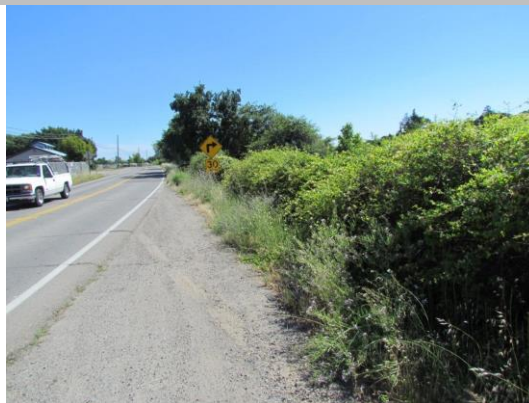
Photo 1 of 1 : SP\_2016\_RD0554\_176\_32\_20160316\_00053.jpg

LM Start	0.05	Rating **	M	Issue No.	32
LM End	0.39	Issue Type +	Ma	Location *	WS
Category	Earthen Levee			GPS Latitude/Longitude	
				Start	End
Item	Vegetation			38.249050 °	38.244495 °
				-121.509977 °	-121.511830 °
DWR ID	DWR_RD0554_01_f_2015_32				
Comment Code					
V1 : Control annual grass and weeds on the levee slopes and easements.					
Inspector Comment					
This section on the waterside has growth covering the fence at levee mile 0.05 and vegetation on the slope.

RD 554 Levee mile 0.05 waterside shoulder.

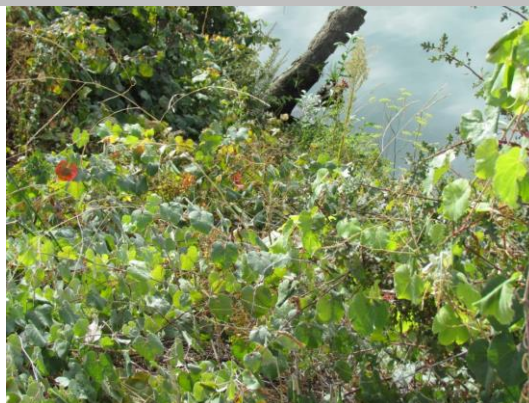
Photo 1 of 1 : SP\_2016\_RD0554\_176\_11\_20160223\_00003.jpg

LM Start	0.10	Rating **	U	Issue No.	11
LM End	0.10	Issue Type +	Ma	Location *	WS
Category	Earthen Levee			GPS Latitude/Longitude	
				Start	End
Item	Erosion / Bank Caving			38.248262 °	38.248262 °
				-121.509901 °	-121.509901 °
DWR ID	DWR_RD0554_01_s_2014_11				
Comment Code					
E1 : Note and monitor erosion site.					
Inspector Comment					
This is not a new erosion site, repairs are needed. One tree has fallen into the Sac River at the erosion site. This site can be seen better from the river by boat. The wild grapes blocks the view from the waterside shoulder looking down the slope. There was no new picture taken of this issue.

Erosion on waterside toe dead tree fallen at erosion site.

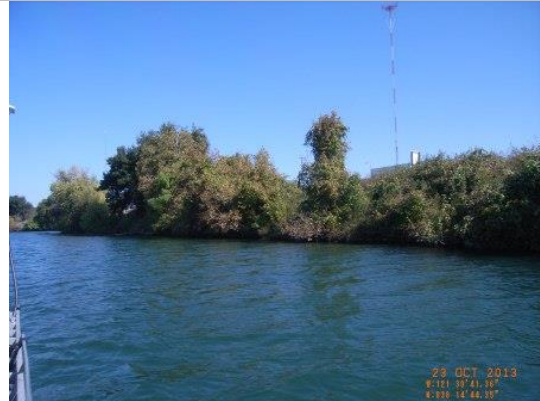
Photo 1 of 2 : SP\_2016\_RD0554\_176\_1\_20160223\_00001.jpg

LM Start	0.26	Rating **	M	Issue No.	1
LM End	0.36	Issue Type +	Ma	Location *	WS
Category	Supplemental			GPS Latitude/Longitude	
				Start	End
Item	2015 USACE Erosion Survey, DRAFT			38.246222 °	38.245017 °
				-121.510878 °	-121.511740 °
DWR ID	DWR_RD0554_01_s_2016_1				
Comment Code					
Inspector Comment					
2009 - Tension cracks on road on top of levee. Erosion into the levee slope and mass failure. 2013 - Short vertical sections at bank toe. 2015: No observed changes. [2015 Site ID: SAC_27-0_L]

USACE 2013 Photo #1

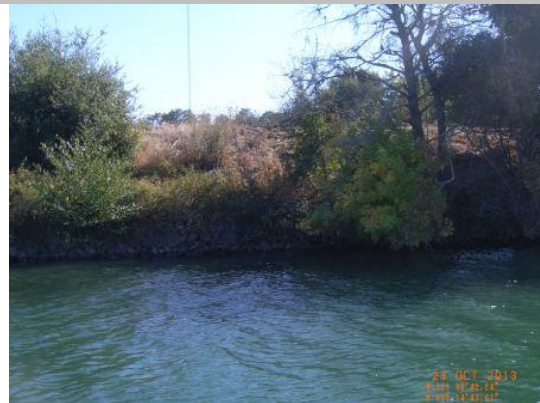
Photo 2 of 2 : SP\_2016\_RD0554\_176\_1\_20160223\_00002.jpg

USACE 2013 Photo #2

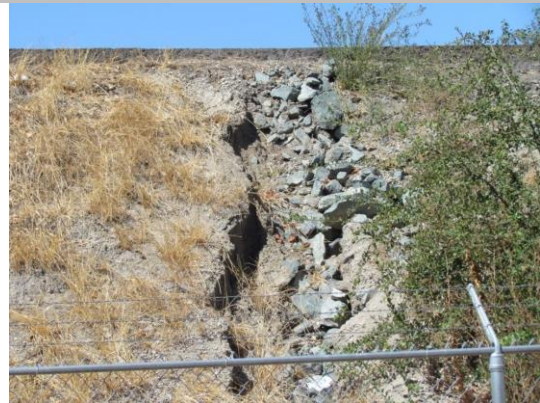
Photo 1 of 1 : SP\_2016\_RD0554\_176\_13\_20160223\_00004.jpg

This erosion along the landside levee slope is not new, it was reported two years ago.

LM Start	0.32	Rating **	U	Issue No.	13
LM End	0.32	Issue Type +	Ma	Location *	LS
Category	Earthen Levee			GPS Latitude/Longitude	
				Start	End
Item	Erosion / Bank Caving			38.245389 °	38.245389 °
				-121.511085 °	-121.511085 °
DWR ID	DWR_RD0554_01_s_2014_13				
Comment Code					
E2 : Schedule repair of erosion site prior to the next inspection.					
Inspector Comment					
The District has scheduled repairs this season.

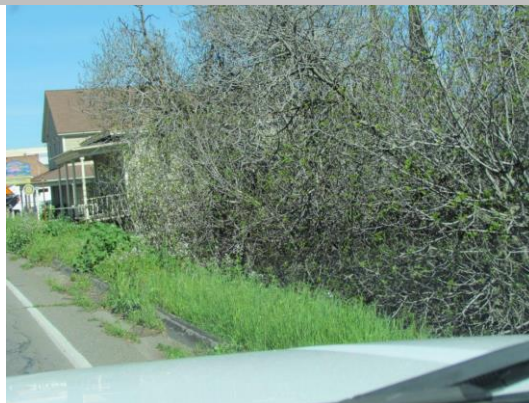
Photo 1 of 1 : SP\_2016\_RD0554\_176\_20\_20160316\_00054.jpg

Woody tree growth on the landside shoulder and slope. Also tall grasses at this location.

LM Start	0.77	Rating **	U	Issue No.	20
LM End	0.81	Issue Type +	Ma	Location *	LS
Category	Earthen Levee			GPS Latitude/Longitude	
				Start	End
Item	Vegetation			38.240128 °	38.239630 °
				-121.515974 °	-121.516418 °
DWR ID	DWR_RD0554_01_s_2014_20				
Comment Code					
V2 : Remove the wild growth other than native grasses from the levee slopes.					
Inspector Comment					
Control the tall weeds and remove these fig trees from the landside slope.
